PORT AND HARBOUR RESEARCH INST TOKYO (JAPAN)
APPARENT WASTING INDEX OF EMBANKMENTS.(U)
DEC 76 F TERUAKI, I MOTOHARU

4. TITLE (and Subtitle) APPARENT WASTING INDEX OF EMBANKMENTS, ⑥		5. TYPE OF REPORT & PERIOD COVERED
7. AUTHOR(s) ⑩ Furudo, Teruaki Iguchi/Motoharu		6. PERFORMING ORG. REPORT NUMBER Technical Note, No. 149 ✓ 8. CONTRACT OR GRANT NUMBER(s)

9. PERFORMING ORGANIZATION NAME AND ADDRESS The Port and Harbor Research Institute Ministry of Transportation Tokyo, Japan		10. PROGRAM ELEMENT, PROJECT, TASK AREA & WORK UNIT NUMBERS

- I. Preface
- II. Wasting of Coastal Embankments
- III. Wasting of Coastal Embankments and Wasting Indicators
 - A. Causes of Damages to Coastal Embankments and Sea Walls

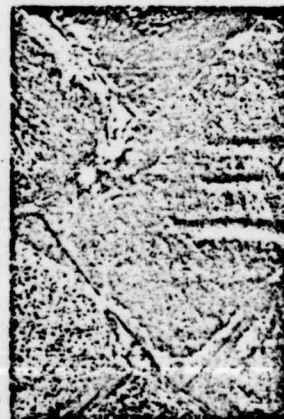
Photo 5.2 - Condition of Masonry (scoured masonry)

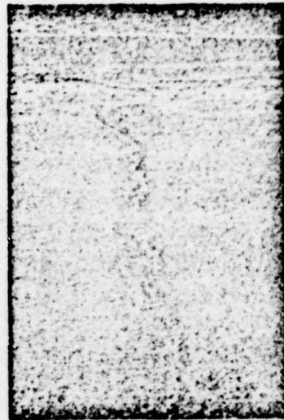
Photo 5.4 - Crack of
Crown

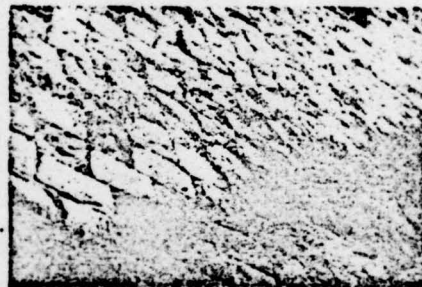
Photo 5.6 - Masonry Condition (scoured masonry)

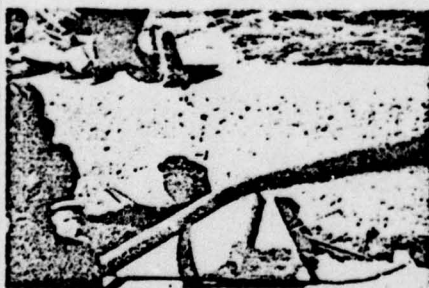
Photo 5.15 - Wave Deflector Crack (back side)

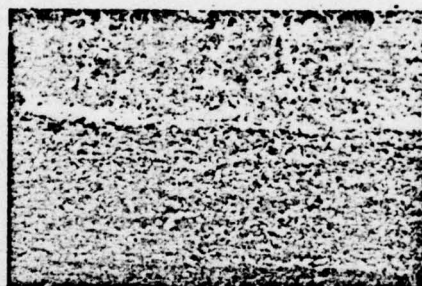
写真 - 5.25 表のり工の摩耗

Photo 5.25 - Abrasion of Face Spread

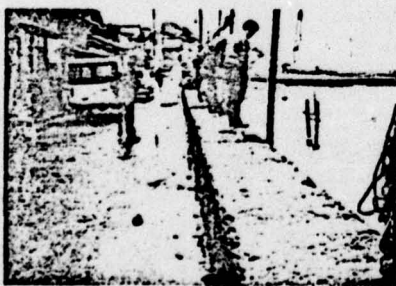
写真 - 5.26 水叩工の沈下 (背後に水たまり)

Photo 5.26 - Sinking of Apron (water puddle to the rear)

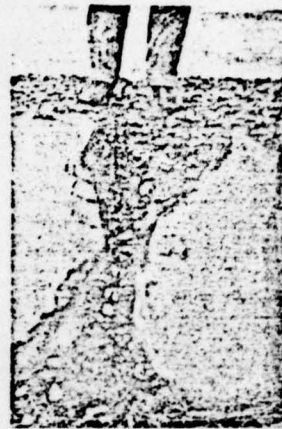
写真 - 5.29 波返し工の摩耗

Photo 5.29 -
Abrasion of
Wave Deflect
or

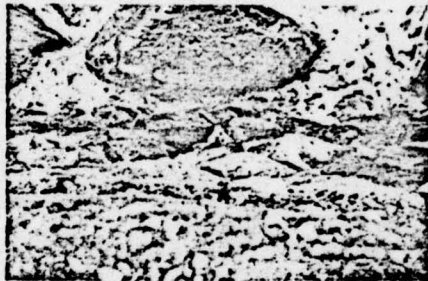
写真 - 5.30 表のり工間知石の抜け出し

Photo 5.30 - Erosion of
"Kanchi" Stones of Face
Spread

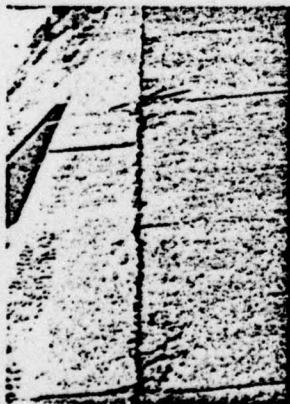
写真 - 5.34 天ば工の沈下、角欠け

Photo 5.34 - Angular Break, Sinking of Crown

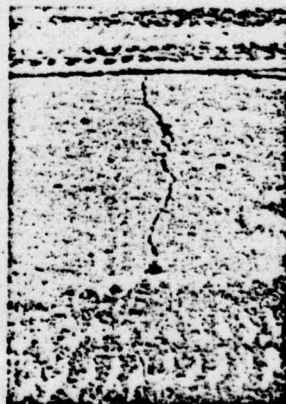
写真 - 5.35 表のり工のクラック

Photo 5.35 - Crack of Face Spread

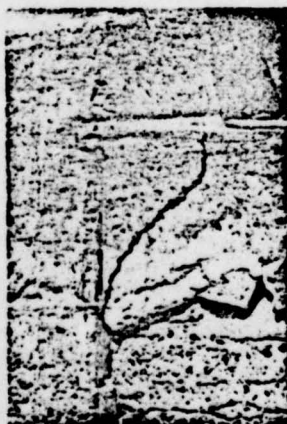
写真 - 5.38 表のり工のクラック

Photo 5.38 - Crack of Face Spread

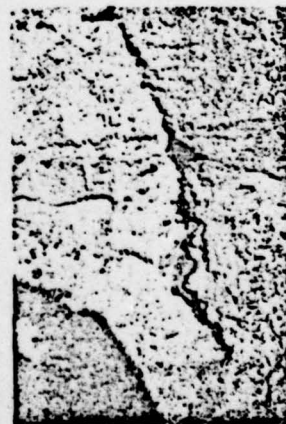
写真 - 5.39 表のり工のクラック

Photo 5.39 - Crack of Face Spread

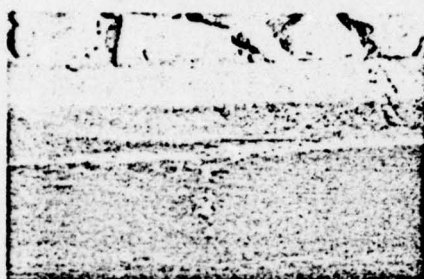
写真-5.44 表のり工のクラック

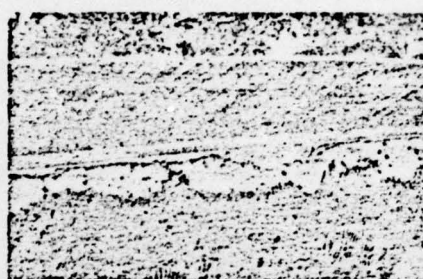
写真-5.45 波返し工背後にできた天ば工クラック

Photo 5.45 -
Crown Crack
That Deve-
loped Behind
Wave Deflect-
or

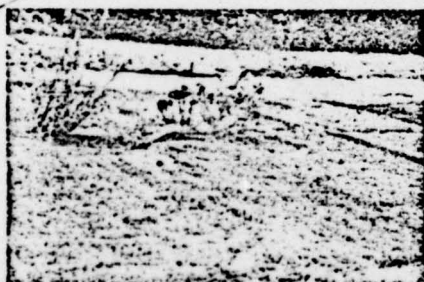
写真-5.46 裏のり工のクラック

Photo 5.46 - Crack of
Rear Spread

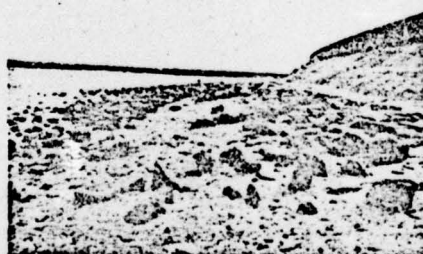
写真-5.47 前面根固石の散乱

Photo 5.47 - Scattering of
Reinforced Bedding Rocks
on the Front Shore

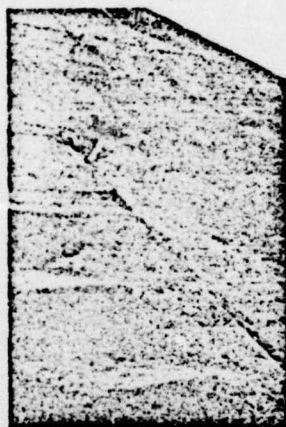
写真 - 5.49 表のりの目地のかけ

Photo 5.49 - Ground Site Break of Face Spread

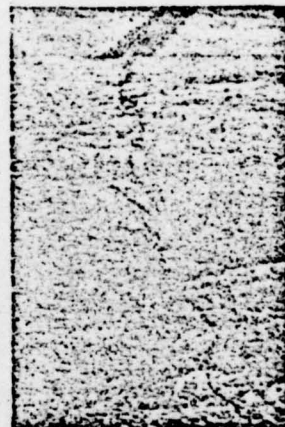
写真 - 5.50 表のり工のクラック

Photo 5.50 - Crack of Face Spread

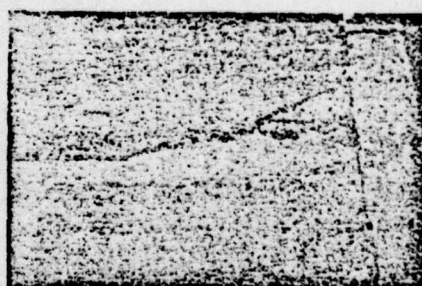
写真 - 5.54 天板コンクリートの損傷

Photo 5.54 - Damaged Crown Concrete

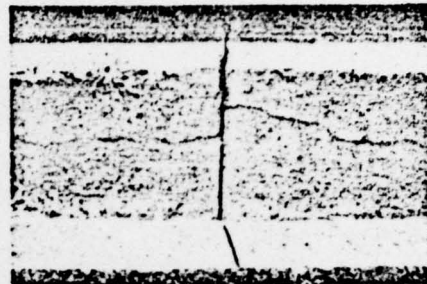
写真 - 5.58 表のり工小段のクラック

Photo 5.58 - Small Step Crack of Face Spread

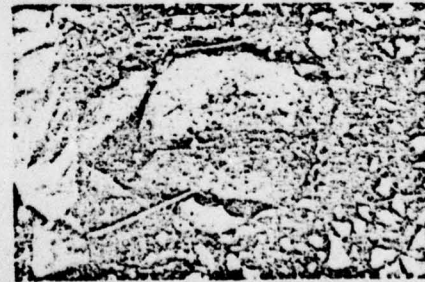
写真 - 5.65 表のリ工小段部の内部捨石の露出

Photo 5.65 - Internal Rip-rap Exposure of Small Step Section of Face Spread

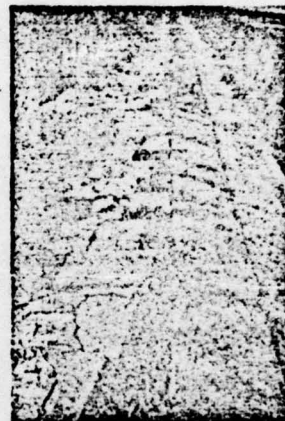
Embankment located south of Suo Nada; believed wave disturbance to be very little; reclaimed embankment with paddy fields in the rear; exposed face spread structures but no change in normal line; wave reflector concrete shows wear but no change; normal line right angle crack in corner angle section; block crack and 20 cm sinking of crown blocks due to dump car traffic on crown; rich growing mixed grass on rear spread.

写真 - 5.71 天板工の沈下, ブロックの割れ
Photo 5.71 - Sinking, Block Crack of Crown

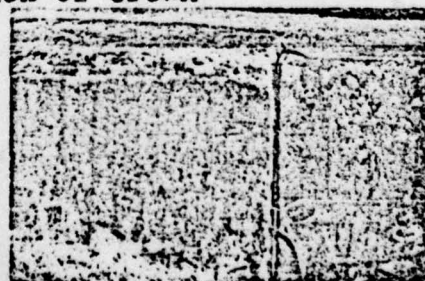
写真 - 5.73 波返し工の目地のかけ
Photo 5.73 - Wave Deflector Ground Site Break

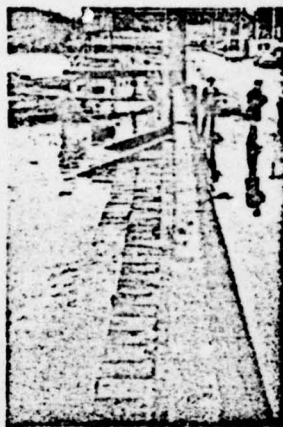
Sea wall located north of Shima peninsula; mouth of the harbor opens into Ise Wan but sea wall located deep inside the harbor and thus, the occurrence of strong wave action appears fairly remote; busy trunk railroad line causing heavy traffic located to the immediate rear; vertical concrete parapet constructed along railroad line but its base adjacent to river mouth and thus relatively weak, causing uneven sinking of serious nature; a small pool located between sea wall and rear railroad line; large crack in concrete parapet as well as angular break caused by friction in several places; face spread; step concrete blocks but serious uneven sinking; about a 4-cm breach between face spread blocks and parapet; serious abrasion of tidal [river?] section concrete.

Photo 5.74 - General View (for showing the sinking condition)

写真 - 5.74
全景（沈下のようなすが明らか）

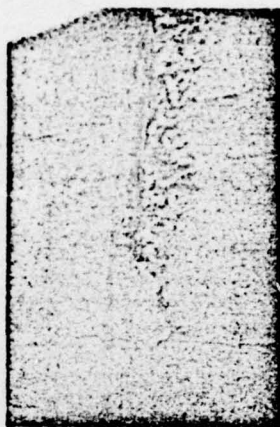
Photo 5.75 - Angular Break of Parapet (exposure of ferro-concrete)

写真 - 5.75
胸壁の目地の角欠け（鉄筋の露出）

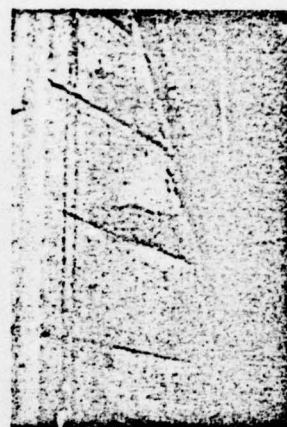
Photo 5.76 - Concrete Crack of Corner Angle Section

写真 - 5.76
隅角部のコンクリートの割れ

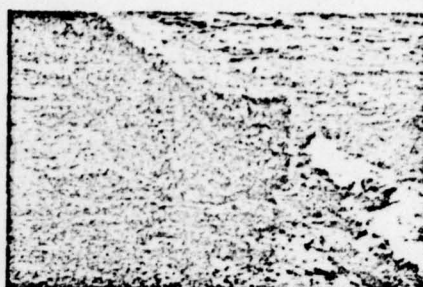
Photo 5.80 -
Damage to Wave
Reflector

写真 - 5.80 波返し工の損傷

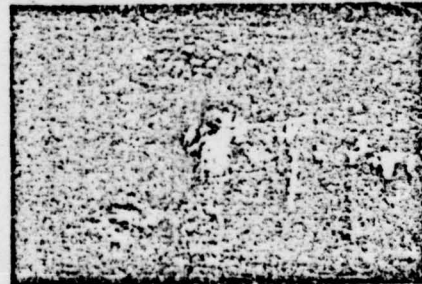
写真 - 5.86 波返し工の摩耗
Photo 5.86 - Abrasion of Wave Deflector

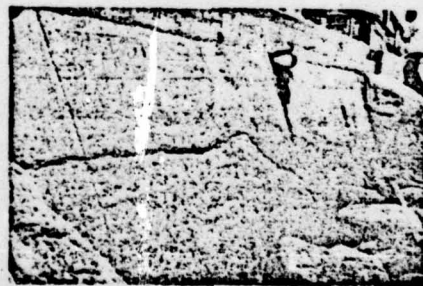
写真 - 5.88 表のり工のクラック

Photo 5.88 - Crack of Face Spread

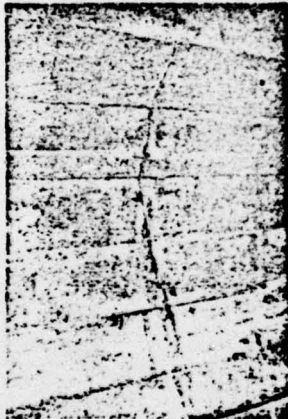
Harbor located in Uchinoumi; believe no action of wave against sea wall; paddy fields located to the rear; about 2 cm wide horizontal crack in mid-section of face spread; throughout the length of wave deflector, crack observed around the mid-section (about 7-8 m) of almost every 15-m block; no covering on aprons but no danger of erosion from overtopping waves and thus, could be left without any change.

写真-5.93
波返し工の縦方向クラック

Photo 5.93 - Vertical Direction Crack of Wave Deflector

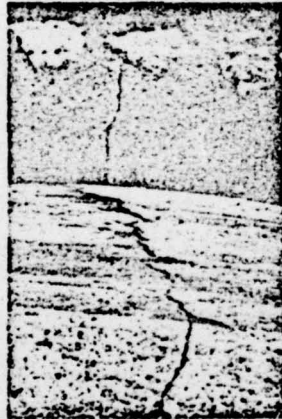
写真-5.94 表のり工のクラック

Photo 5.94 - Crack of Face Spread

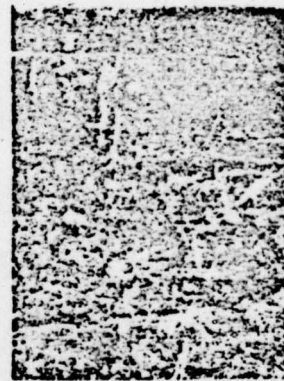
写真-5.95 波返し工のクラック

Photo 5.95 - Crack of Wave Deflector

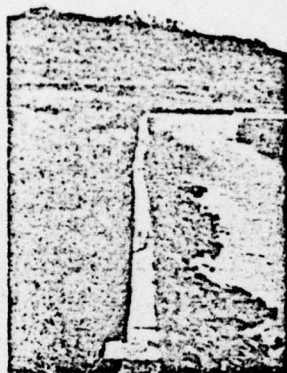
Harbor facing Uchinoumi; sea wall constructed as an aqueduct sea wall between two reclaimed lands and thus, completely free of wave action; thermal power plant, factories, etc., located to the rear; constructed around 1929 and no abrasion observed on parapet due possibly to use of abundant concrete; normal line indentations visible in face spread as well as aberration to the front and back at the ground site, but these believed to be from the time of construction; a number of cracks and angular damage as well as exposure of tidal [river?] section; observed meandering normal line (presumably from the time of construction) and soil erosion of wave deflector; about 4 cm aberration of both front and back of ground site; observed inclined crack of ground site; mixed grass growing on apron; about 50 cm deep, 1 m wide, and 2 m long cave-in in back part of parapet indicating erosion of fills.

Photo 5.96 - General View (showing normal line indentation)

写真-5.96 全景(法線の凸凹)

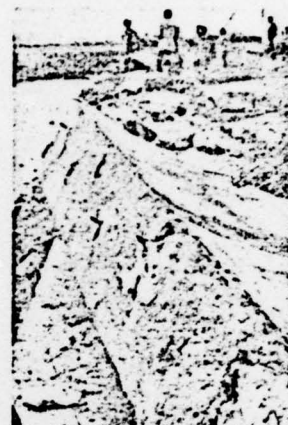
Photo 5.98 - Condition of Parapet Concrete Pile Joint

写真-5.98
胸壁コンクリートの打継部の状況

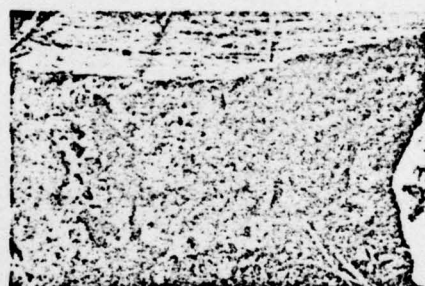
写真-5.100 コンクリート断面(撤去されたコンクリート)

Photo 5.100 - Concrete Cross-Section (Eroded concrete)

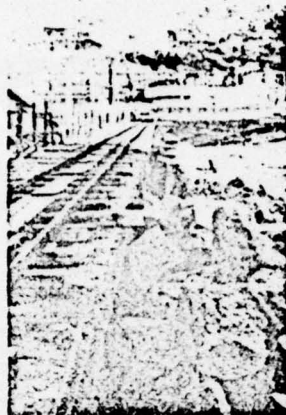
写真 - 5.103 前面消波工の施工状況

Photo 5.103 - Wave Dissipation Work Scene for the Front Side

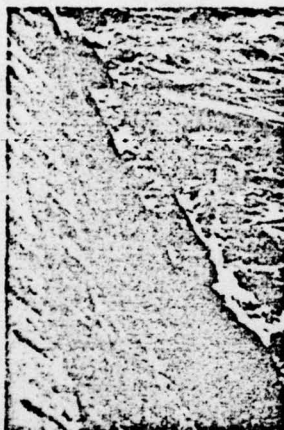
写真 - 5.118
前面根固部コンクリートの破壊

Photo 5.118 - Des-
truction of Front
Reinforced Bedding
Concrete

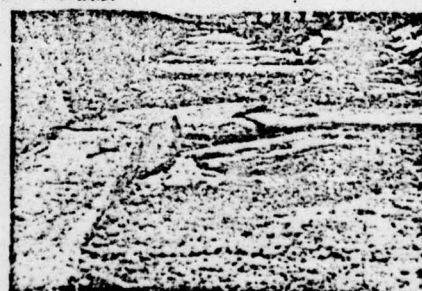
写真 - 5.121 裏込の吸出しによる水叩工の陥没

Photo 5.121 - Apron Cave-
in From Erosion of Fills

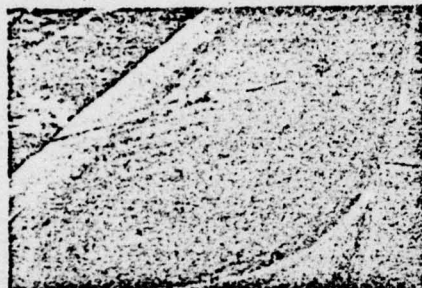
Photo 6.1 - Normal Line Direction Crack of Face Spread

写真 - 6.1 表のり工法線方向のクラック

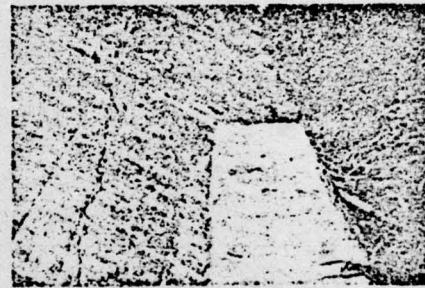
写真 - 6.4 裏のり工法線方向のクラック

Photo 6.4 - Normal Line Direction Crack of Rear Spread

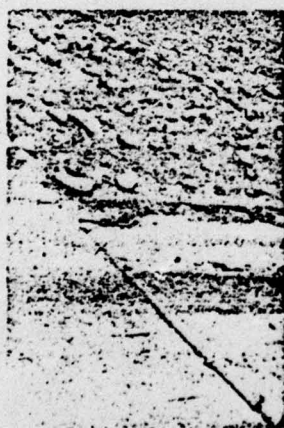
写真-6.7 感潮部コンクリートの劣化

Photo 6.7 - Wasting of Tidal Section Concrete

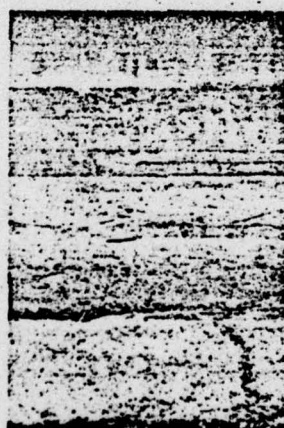
写真-6.8 表のり工全面にわたる断面方向クラック

Photo 6.8 - Example of Section Direction Cracks Throughout the Face Spread

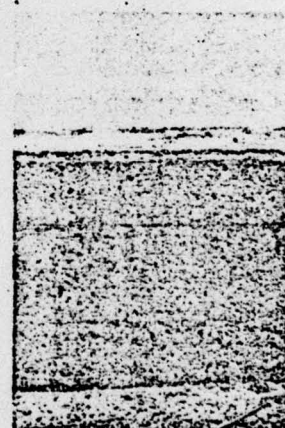
写真-6.9 波返し工のクラック

Photo 6.9 - Crack of Wave Deflector

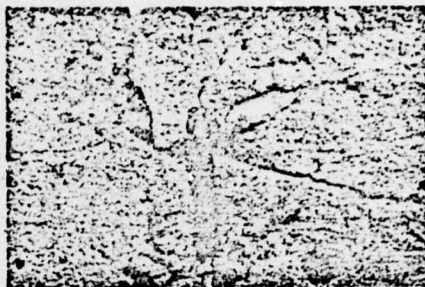
Photo 6.11 - Exposure of Ferro-
Concrete of Wave Deflector

写真-6.11 波返し工の鉄筋の露出

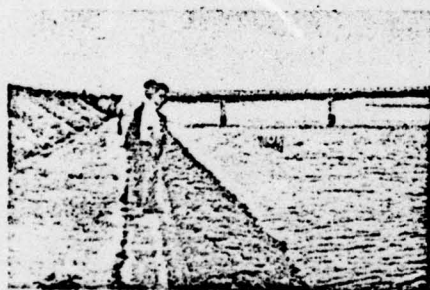
写真 - 6.15 表のリ工および根固工の状況

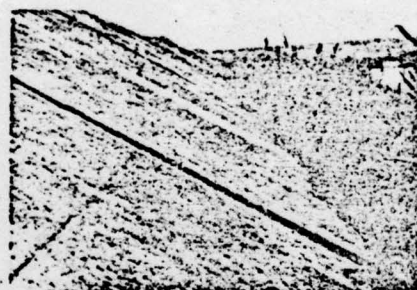
写真 - 6.16 表のリ工のはらみ

Photo 6.16 - Exposed Face Spread

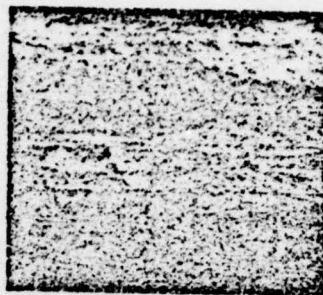
Photo 6.20 - Photo 6.20 裏のり工の法線直角方向のクラック
Normal Right Angle Crack of Rear Spread

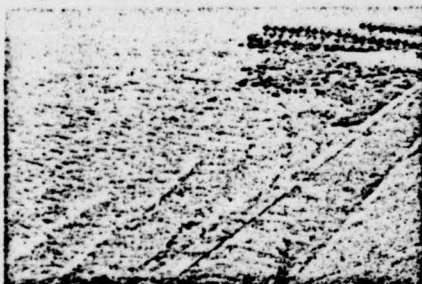
写真-6.25 橋門付近の汀線の後退

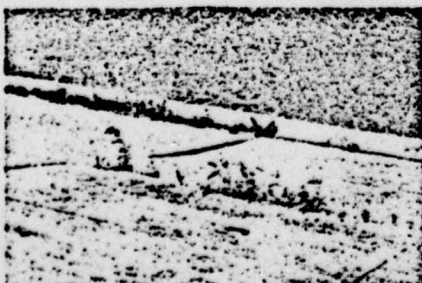
写真-6.27 表のり工のスラブの折れ

Photo 6.27 - Rear Spread Slab Break

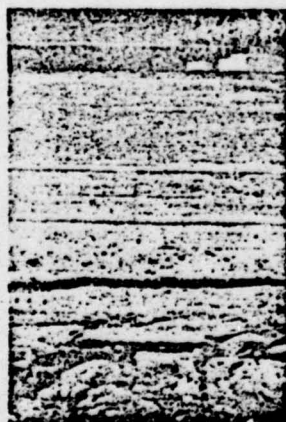
写真-6.35 表のり工下部
コンクリート打継目の角かけ

Photo 6.35 - Angular
Break of Lower Section
of Face Spread at Con-
crete Pile Joint

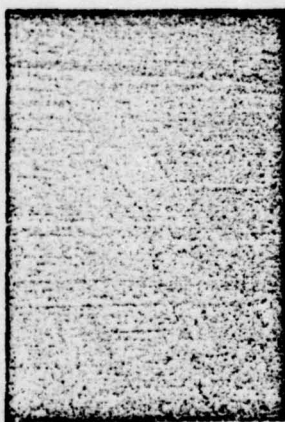
写真-6.36 表のり施工
目地近くの法線直角方向クラック

-Photo 6.36 - Normal
Line Right Angle Di-
rection Crack of Face
Spread Near Work Site

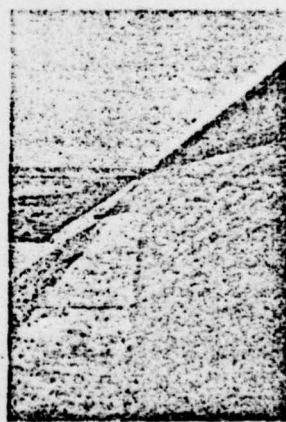
写真 - 6.37
表のり下部の腹付けコンクリート

Photo 6.37 - Added Concrete At the Center Section of the Lower Part of Face Spread

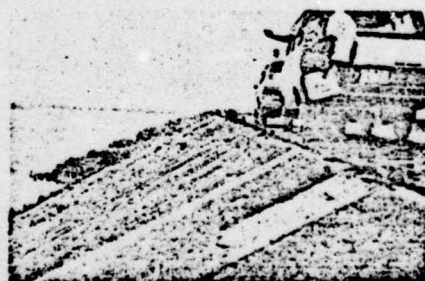
写真 - 6.39 裏のりかよび潮遊び

Photo 6.39 - Rear Spread and "shio asobi" ["tidal plan?"]

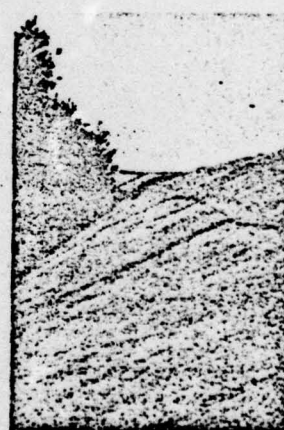
写真-6.48 裏のり被覆コンクリートの摩耗

Photo 6.48 - Concrete Abrasion of Rear Spread Armor
